Deliverable report on implemented solutions in Tallinn, Turku and Söderhamn with assessment of system performance

The present document is a summary report for the Heawater¹ project's deliverables DI1.2.1, DI1.2.2, DI1.3.1, DI1.3.2, DI1.4.1 and DI1.4.2, detailing the implementation of pilot solutions to protect and restore urban streams and the performance assessment of these solutions.

The report was compiled by Turku University of Applied Sciences, with contributions by the City of Tallinn, Tallinn Technical University, and the Municipality of Söderhamn.

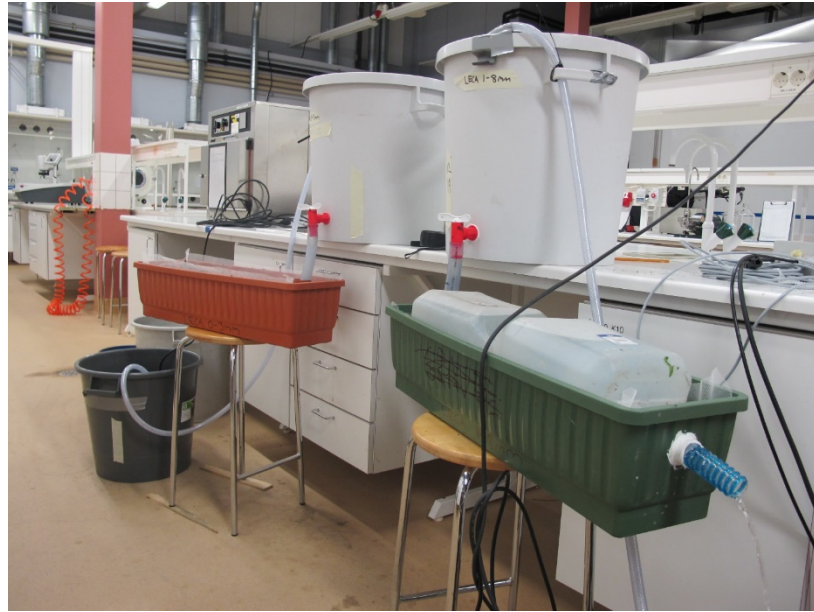
Fig 1. Laboratory set-up for the second test with Leca® LWA.

Research for different methods available for managing water quality problems in the pilot streams was conducted. Small sized filtering structures were chosen to be developed. Two separate laboratory tests were conducted during summer and fall 2019 to help with the decision making for the best materials. In the first test set-up gravel and Leca® LWA (Light Weight Aggregate) were tested with standing and flowing water. Water used in both tests was collected from the pilot stream in Itäharju, Turku. The aim of the first test was to see if there are chemical processes between the impurities in the water and Leca® LWA or is there only physical filtration of the impurities. The second laboratory test was made to compare two different pore size Leca® LWA and their ability to retain heavy metals from the ditch water. Leca® LWA, pore size 0–3mm and 1–8mm, were first flushed with tap water and then placed in the test boxes (Fig. 1).

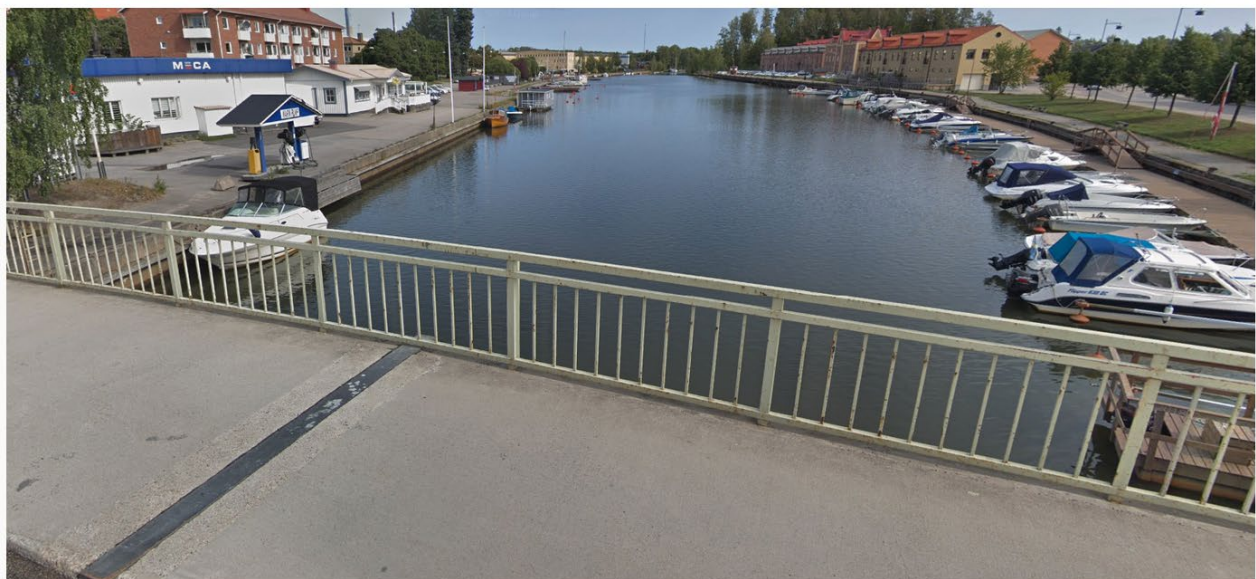
Fig 2. The last bridge over the river Söderhamnsån before it flows in the bay of Söderhamn.

Söderhamnsån runs through the city of Söderhamn and ends in the narrow bay to Söderhamn and finally in the Baltic Sea (Fig. 2). It is highly affected by human activities. The river runs through a flat agricultural landscape with clayey soils and few lakes that can stabilize the flow. During flood events the water level quickly rises. During peaks the flow can be up to 20 times the normal flow in the river. During peaks there is a big rise in transport of suspended matter and nutrients, mainly phosphor, which leads to over fertilisation in the Bay of Söderhamn. Much of the nutrients stem from farming upstream but the Heawater project provided the possibility to learn more about how the stormwater affects the water quality in the river.

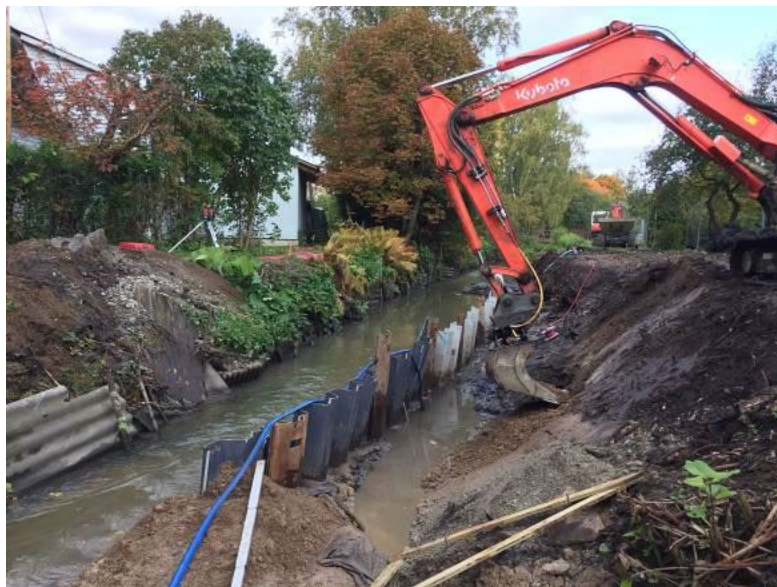
Fig. 5: Use of cofferdams to keep parts of the river bed and banks dry for construction works.

1. An area of the river was isolated and kept dry with the use of barriers (often referred to as a *cofferdam*, Fig. 5), that allowed for unobstructed flow in the remaining part of the river. This method did not work well as the cofferdams placement and removal was time consuming and the water started to leak between the barriers when river flow was high.

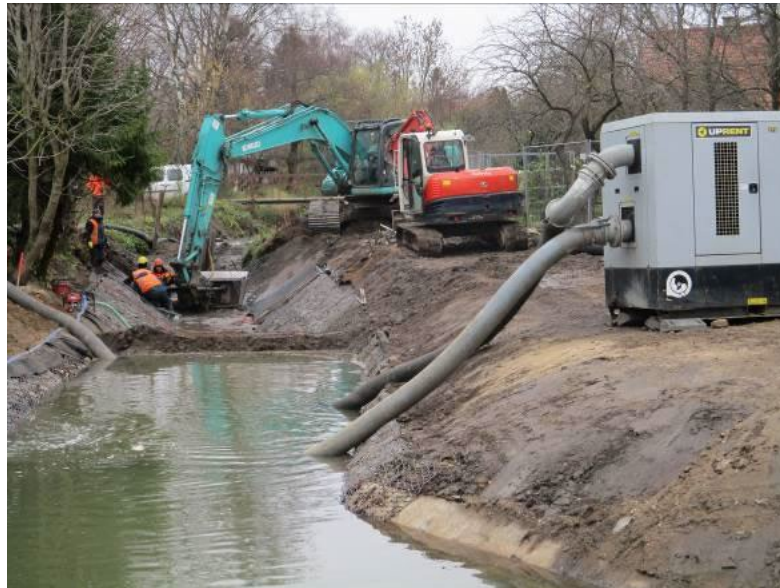
Fig. 6. Section of the river were dammed and drained with two large pumps.

2. A section of the river was isolated using barriers that span the full width of the river. The barriers keep a stretch of the river dry and the water was transferred downstream of the work area by pumping (Fig. 6). For this, two pumps were used. The larger one pumping approx. 170-180 litre/second and smaller one 90-100 litre/second. Due to machine rents and energy consumption this solution was expensive.

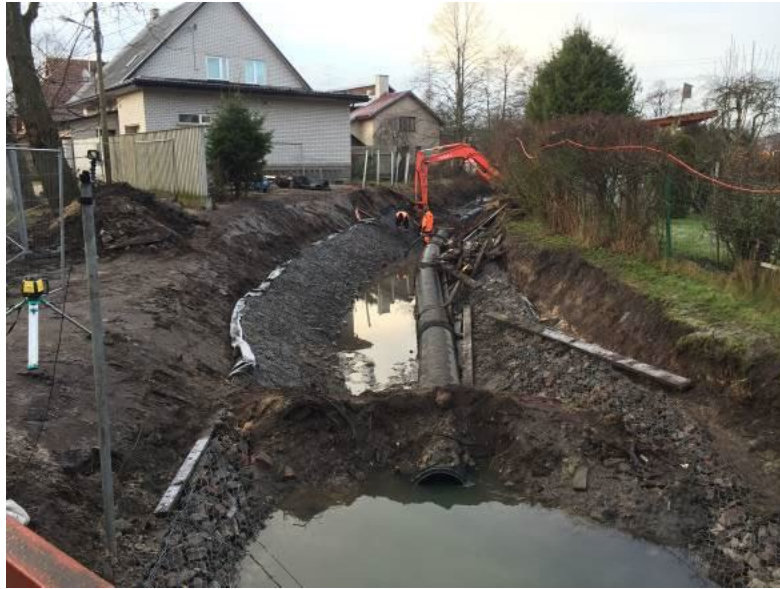
Fig. 7. Temporary draiage of the stream using barriers and drainage pipes.

3. The third method used for temporary draining of the river during construction works utilized barriers (both upstream and downstream) and downstream transfer of water using through gravity-fed flumes/pipes (Fig. 7). See [here](#) for a time-lapse video of the construction works. The pipe diameter was Ø 600 mm and it turned out to be the most effective method to keep dry the work area.

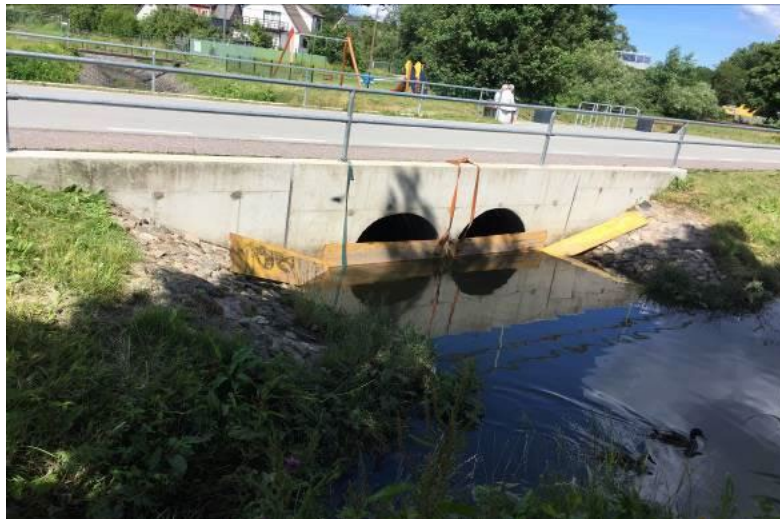
Fig. 8: Blocking of a road culvert to keep the downstream section of the river dry for the period of a few hours to allow for construction works.

4. As fourth approach to temporarily keep the riverbed dry, the culvert of Kõrgepinge street was closed by gates to lower the water level downstream for three hours. The last half of the work was made using this technique (Fig. 8).

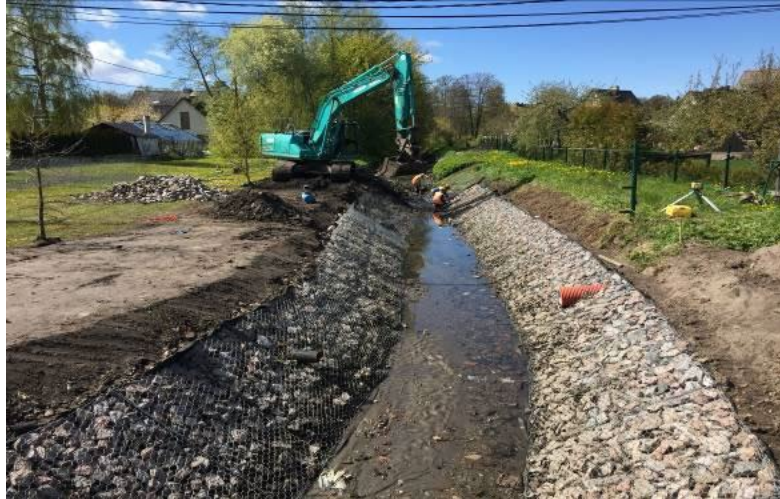
Fig. 9: Placement of the gabions for bank enforcement.

Compared to the initial design, some stream stretches were straightened to make them fit better into the environment and further erosion control mats were placed to prevent soil erosion during wintertime. Eventually, the gabions were placed on the banks on the straightened banks (Fig. 9).

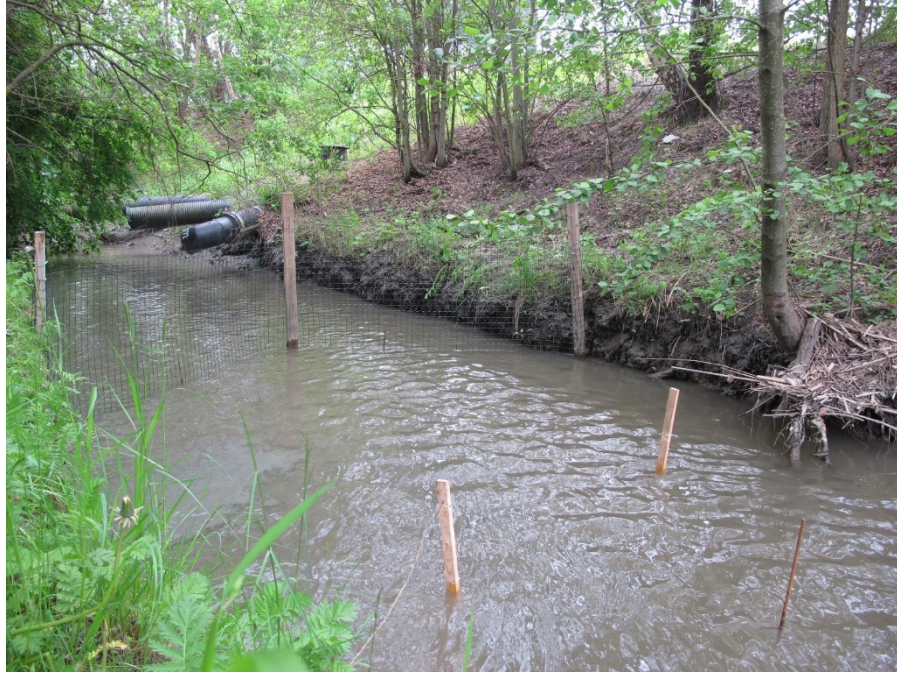
Fig. 10. Litter removal fence in Kuninkoja.

Fence structures were installed for two-week periods in summer 2019 (Fig. 10). Plastic net was tightened between wooden poles and sealed from the banks. Mesh size was chosen to be big enough for small fishes and other aquatic animals to pass the structure. Wooden poles were also installed before the net structure, to catch sticks, hay, and other organic materials. The sites were visited every other day to see the material caught in the net.

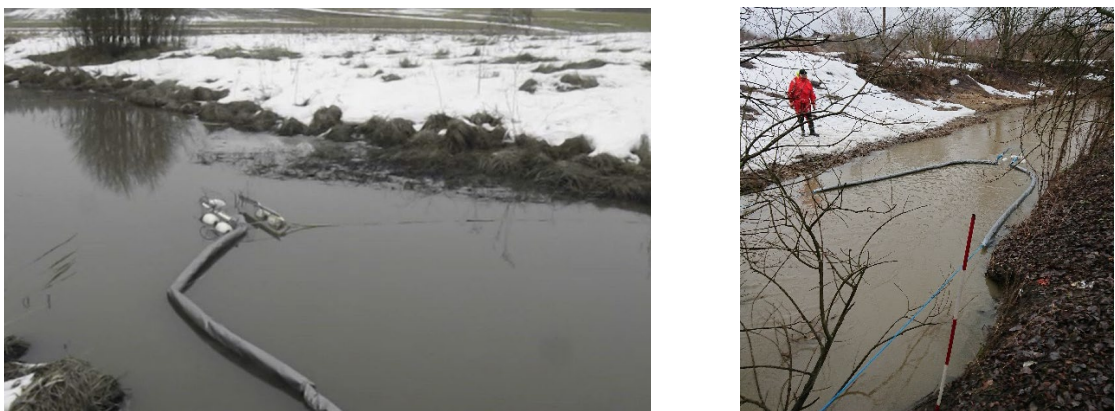
Fig. 12. Litter trap testing during high water level but low flow velocities in left) Jaaninoja and right) Kuninkoja, March 2019.

Testing of a floating litter trap prototype was done during high flow conditions in Kuninkoja. The litter trap consisted of a wire mesh basket, flotation buoys and booms arranged in a funnel shape to guide floating debris in the basket (Fig. 11 & Fig. 12).

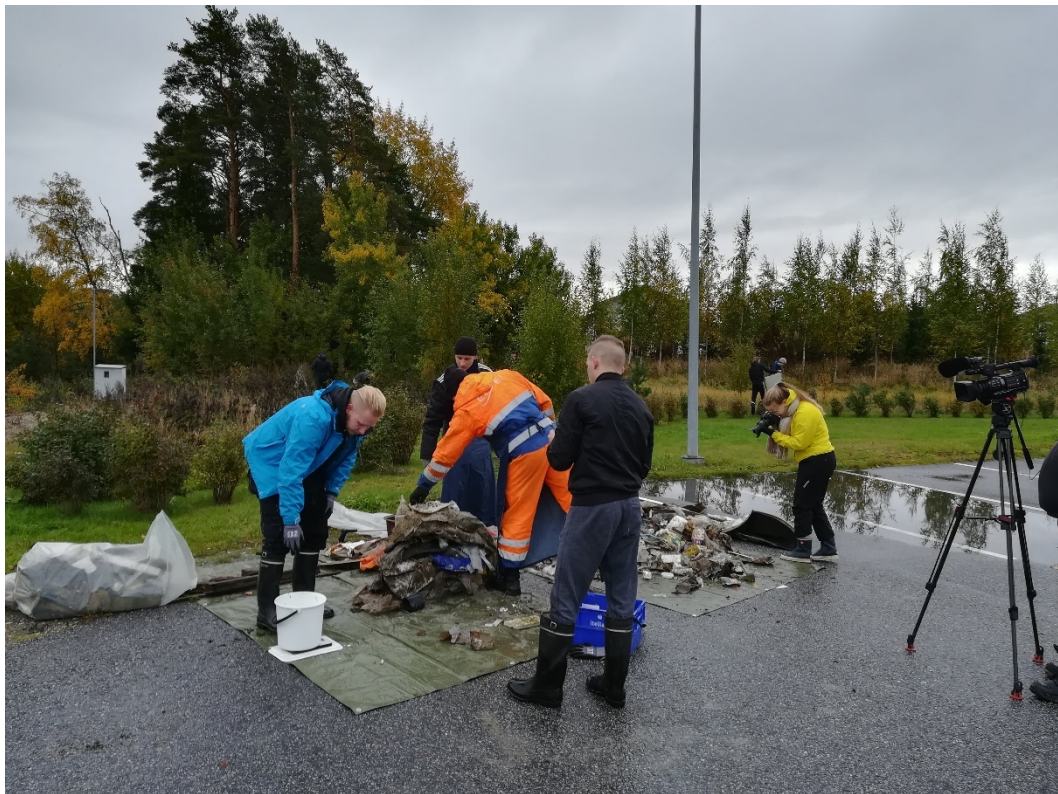
Fig. 13. Students collecting litter found along the Kuninkoja stream on a nearby parking lot.

Within a student project carried out in Heawater, a litter collection campaign within the *Let's Do It!* campaign was organized at a small part of the Kuninkoja stream in the vicinity of a large shopping area (Fig. 13). The campaign yield about 27 kg of litter.

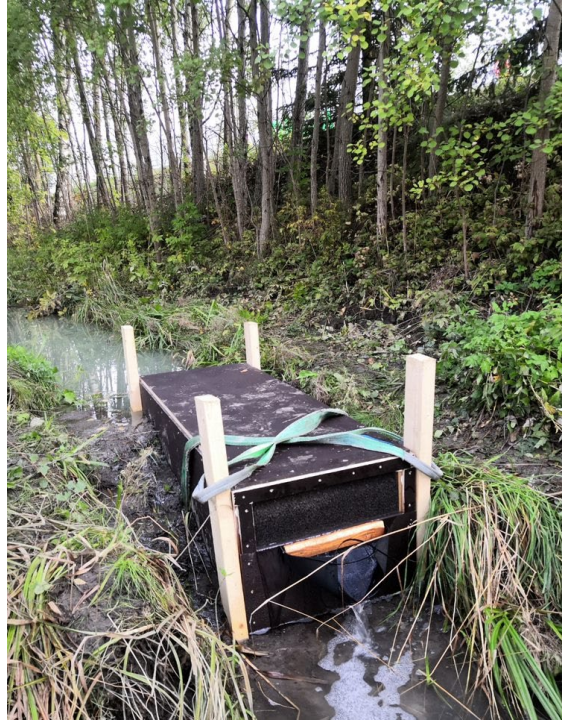
Fig15. Testing of the first filter prototype. View from downstream/outlet side.

The initial test with the first prototype were promising but also revealed some conceptual problems. During low flow conditions, most stream water passed through the filter, however with increasing flow, the limited capacity of the filter caused the upstream flow to bypass the filter box. This led to bank erosion next to the filter. Subsequently, much of the stream flow also passed the filter during low flow conditions.

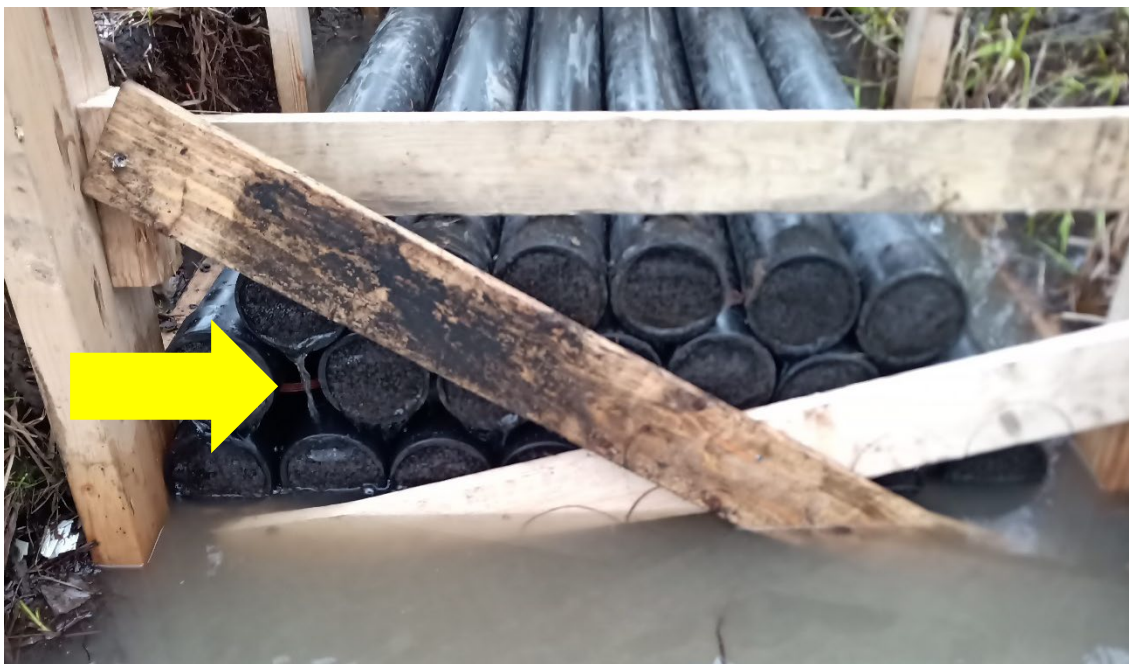
Fig. 18. Pipe filter prototype. View of the downstream sections. Part of the flow passes through the voids between the pipes while the rest passes through the pipes filled with filter granulates. The yellow arrow shows water dripping from a pipe above the downstream water level, indicating a higher water level on the upstream side.

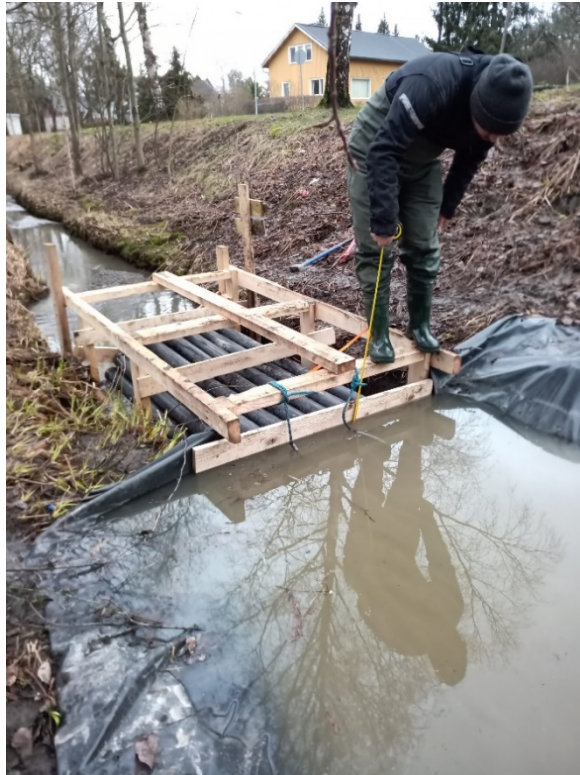
Fig. 19. The pipe filter design during the testing phase. The tarpaulin in the upstream section was added to minimize erosion during higher discharge conditions.

To avoid any bank erosion next to the filter, the stream bed, and banks upstream of the filter were covered with a large tarpaulin (Fig. 19). This concept worked well and was kept until the end of the project's testing period. The functionality of the pipe filter was fair during low discharge condition but other than expected, too much water passed the filter material during intermediate and high discharge conditions. The design also suffered from structural weaknesses during high discharge. Essentially, it was not possible to avoid dislocation of pipes. To prevent the dislocation of pipes, the voids on the upstream end of the filter had to be closed which resulted in a structure like the first prototype but with less filter granulates. Therefore, the filter design was revised another time.

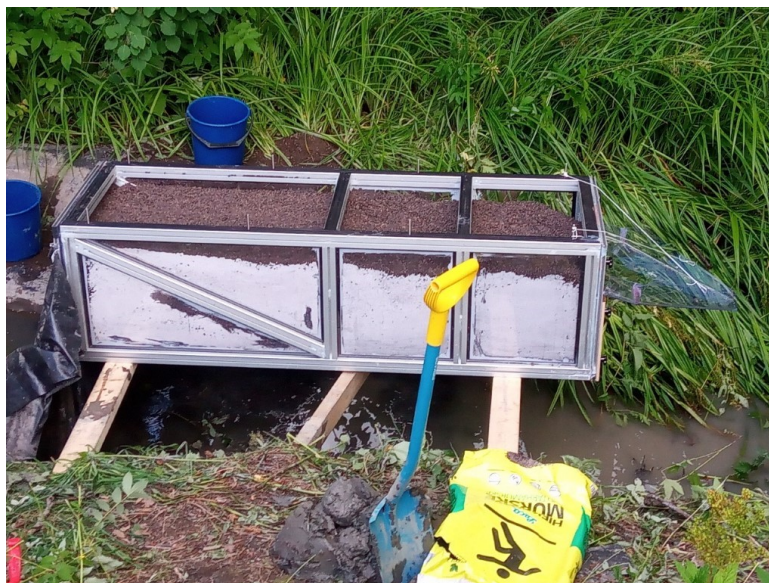
Fig. 25. Final stream filter being prepared for deployment, July 2020.

The final system was deployed in July 2020 (Figs. 25 & 26) and its performance monitored intensively. To obtain data that is suitable for the validation of the performance difference between different filter granulates, the filter was setup with only one filter granulate type at a time, though the structure allows to use different materials in different sections of the filter. The filter was deployed with a vertical inlet and all chambers filled with filter material to test a setup with a maximum flow path lengths and contact time between water and the filter granulate. The final testing included to main periods during which two different filter granulates were tested.

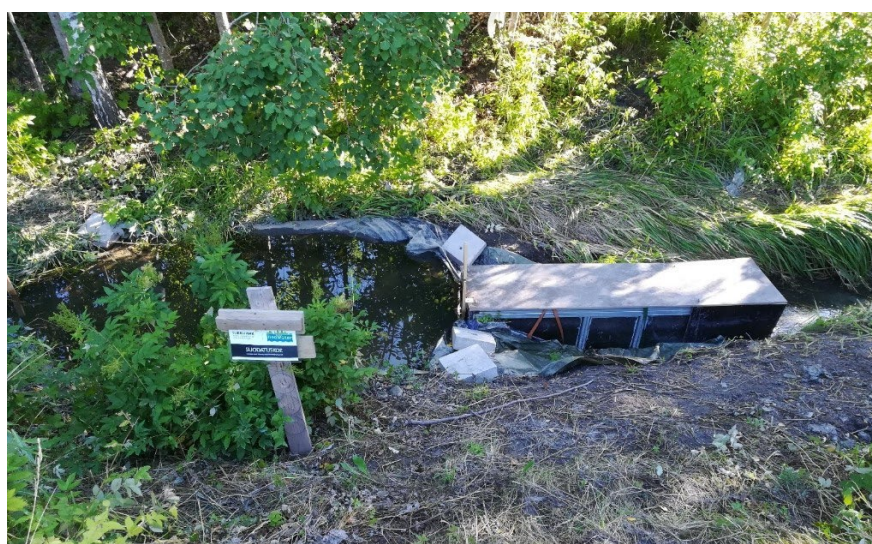
Fig. 26. Final stream filter deployed and in operation. The filter was covered with plywood to protect it from vandalism at the pilot site.

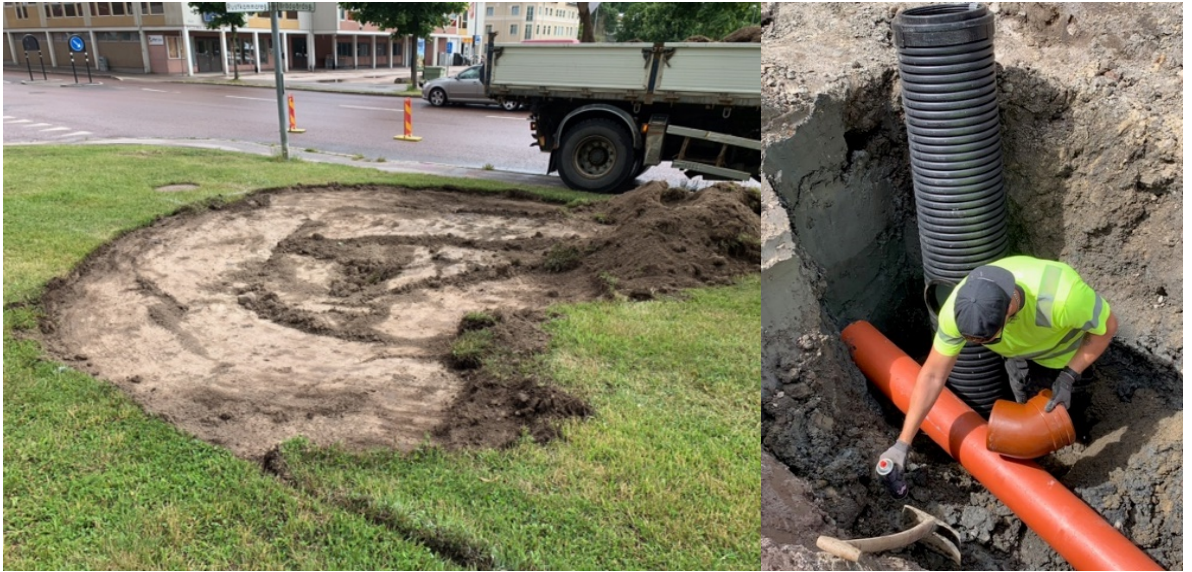
Fig. 23. Digging for the vegetated detention pond and installation of pipes.

The purpose of the vegetated detention pond (Fig. 27 & 28) is to collect rainwater from the streets and the sloping lawn. It delays the water and at the same time some of the hazardous substances transported by stormwater are absorbed.

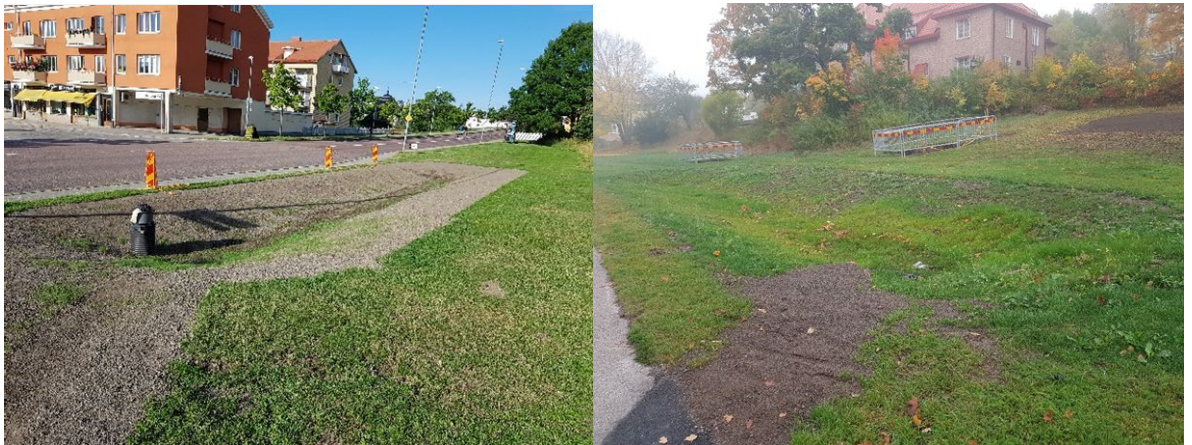
Fig. 24. Finished detention pond at Brädgårdsgatan.

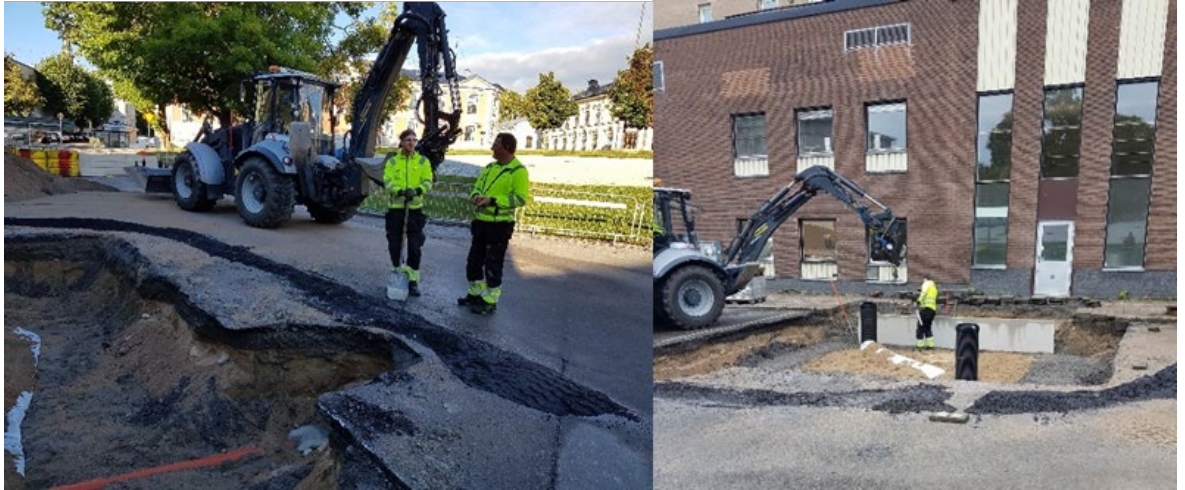
Fig. 25. Excavating the raingarden and installing pipes.

The raingarden is built on a parking lot on the area of two previous parking spaces (Fig. 29). The raingarden collects rainwater that flows over the impermeable surfaces of the parking lot and surrounding streets. The water flows into the flower bed (Fig. 30) where the water is filtered and delayed on its way towards Söderhamnsån via underdrains.

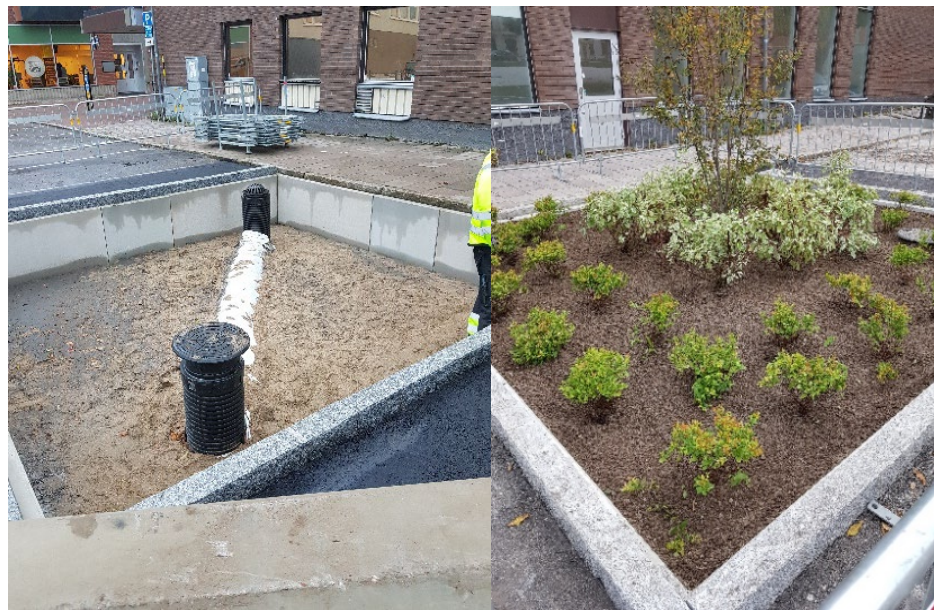
Fig. 30. Left) bed and overflow of the raingarden. Right) finished rain garden.

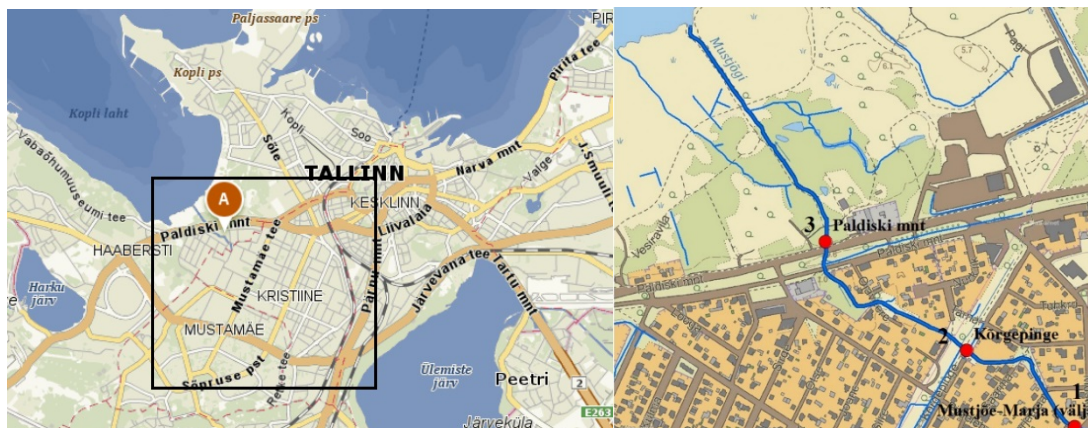
Fig. 31. Mustjoja River catchment area (left side) and monitoring stations: Profile 1- intersection of Mustjõe and Marja streets); 2 - High-voltage line-Kõrgepinge street profile; 3 - Paldiski Road profile (right side)

During the study, three sites of River Mustojägi were sampled: profile 1 - intersection of Mustjõe and Marja streets, high-voltage line - Kõrgepinga Street profile, and Paldiski Road profile (Fig. 31). During the study period May 2018 - September 2020 66 samples were taken, before, during and after the construction works.

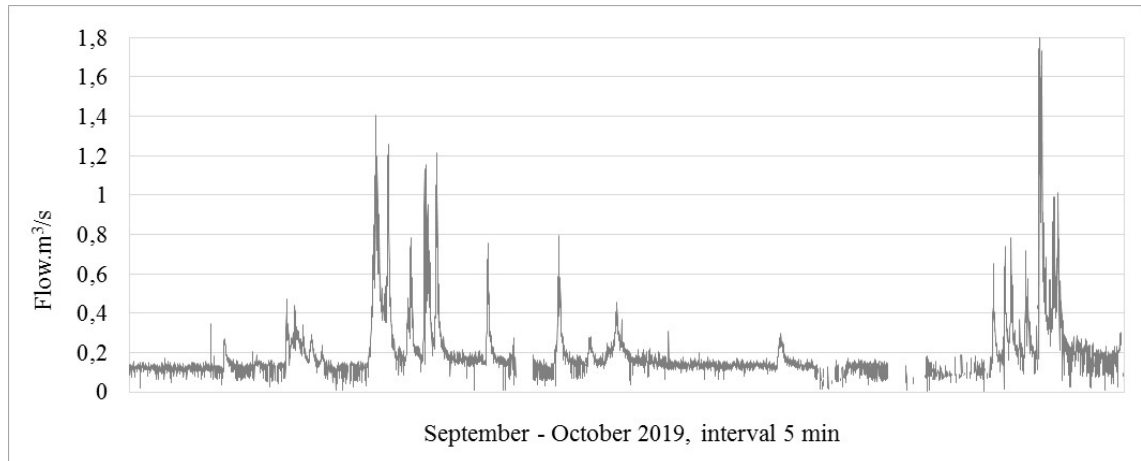
Fig. 32. Flow rate of River Mustoja during the time-period from 1.09.to 6.10.2019

The flow meter was installed in the culvert under Paldiski road in January 2019. The last measurements were made at the beginning of October 2019. During dry weather the flow rate fluctuated between 0.07 m³/s and 0.3 m³/s. In the first half of 2019, there was little rainfall, especially in April. The average runoff in January was 0.14 m³/s, in April 0.18 m³/s. In March and from May to August around 0.9 m³/s. There was more rainfall in the second half of 2019 from August. The rainiest was in September and in October, which has also caused rather high flow rate in River Mustjõgi. Maximum flow rate in September was measured to be 1.4 m³/s and at the beginning of October over 1.8 m³/s (Fig.32).

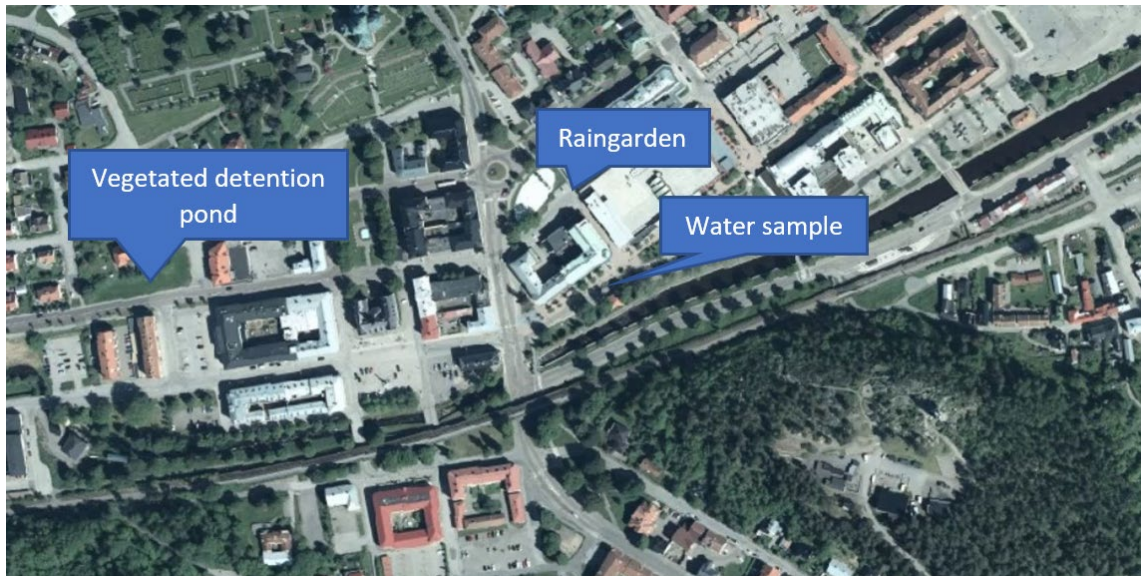
Fig. 51. Construction sites for the raingarden and vegetated detention pond. Place for stormwater sampling.

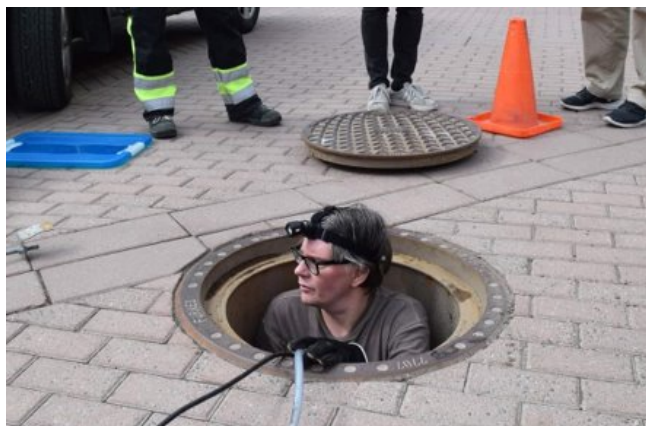
Fig. 52. Installation of the sampling equipment.

The water was taken in a stormwater well downstream of the raingarden (Fig. 52) using an autosampler. Samples were taken 8 June 2020 and 7 October 2020. The timing of the sample collection was critical as it should be a long period of rain. The rain should

have a duration of at least 4 hours and the first flush should be avoided. 24 bottles were collected during the sampling period and subsequently mixed to generate a composite sample. The samples were sent to an accredited laboratory (Synlab) for analysis. The sample taken in June was also analysed for microplastics.

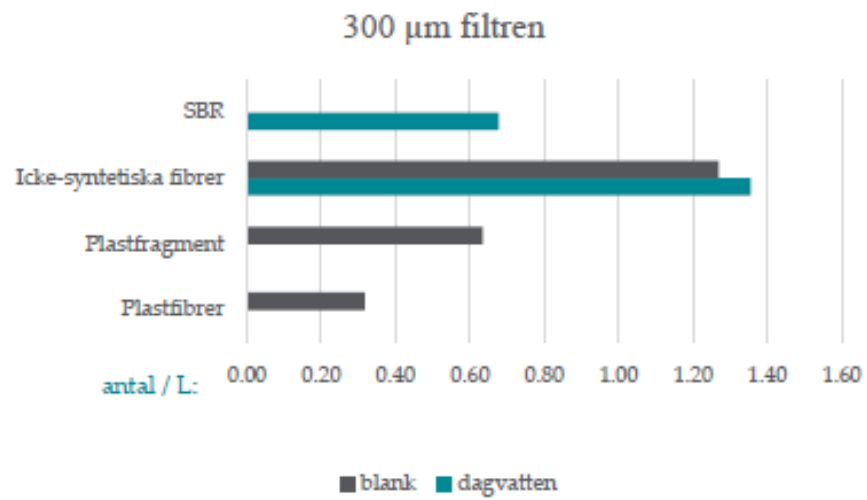
Fig. 55. Microliters 300 μ m filter

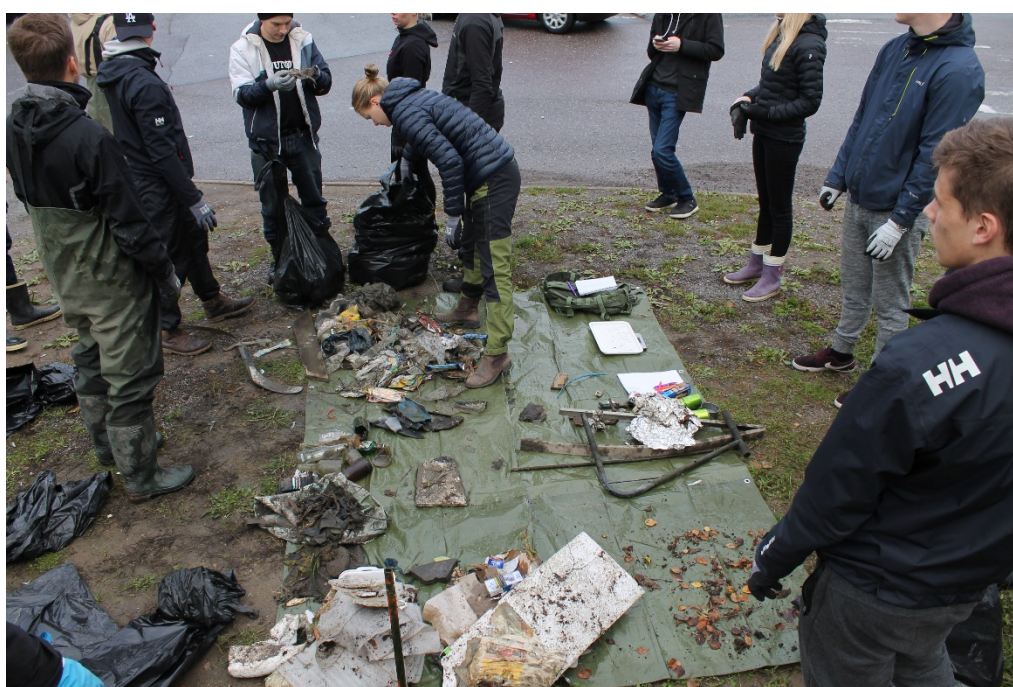
Fig. 58. Student group with litter collected from Jaaninoja. Total amount of litter was 80 kg, from which 20 kg of plastic.

Awareness rising, litter collection campaigns and effective waste management are ways to ensure the best results. Within the Heawater project, two cleaning campaigns along the Jaaninoja and Kuninkoja streams were held (Fig. 58). These campaigns gained visibility in the regional media and should be used on regular basis to create a consciousness of the problem. Littering is a problem especially in the vicinity of construction sites and commercial areas. A combination of stricter waste management requirements and increased environmental consciousness among all actors, including companies and citizens might provide low-cost, effective ways to avoid littering. Marco litter like food packaging and plastic wrappings are also a source of micro pollutants, including plastics and PFAS compounds.
